Environmental and Social Assessment Report

Rehabilitation of Cunha Relief Channel and Structures

Revised Issue C, January 2015.

Agriculture Sector Development Unit (ASDU)

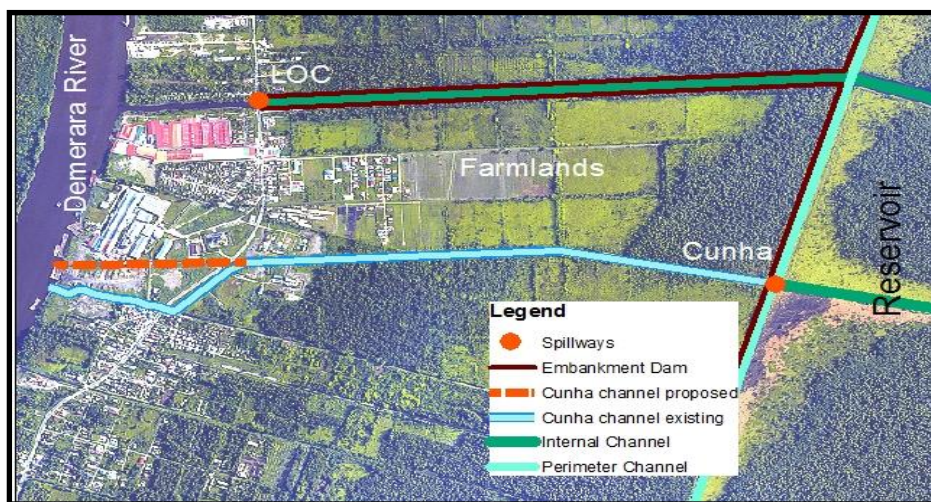
Figure 4: Reinstatement of the Cunha channel to its original alignment

The Cunha Canal is located on the western side of the EDWC and discharges into the Demerara River. Discharge from the canal, at the moment, is affected by the high tides and encroachment in the vicinity of the EBD Public Road and the Demerara River. Around 1990, the Canal was diverted from its original alignment in the vicinity of the EBD Public Road to a smaller discharge channel. This diversion reduced the discharge capacity of the Canal. Sometime later the Canal went into disuse. The discharge through the canal was resuscitated during the floods of 2005. However, the discharge capacity is affected by several factors. The proposed physical works will include the widening of the channel of the Canal, the rehabilitation of the former outlet structure and construction of a bridge on the EBD Public Road where the canal intercepts the road. The project will result in the Canal returning to its original alignment.

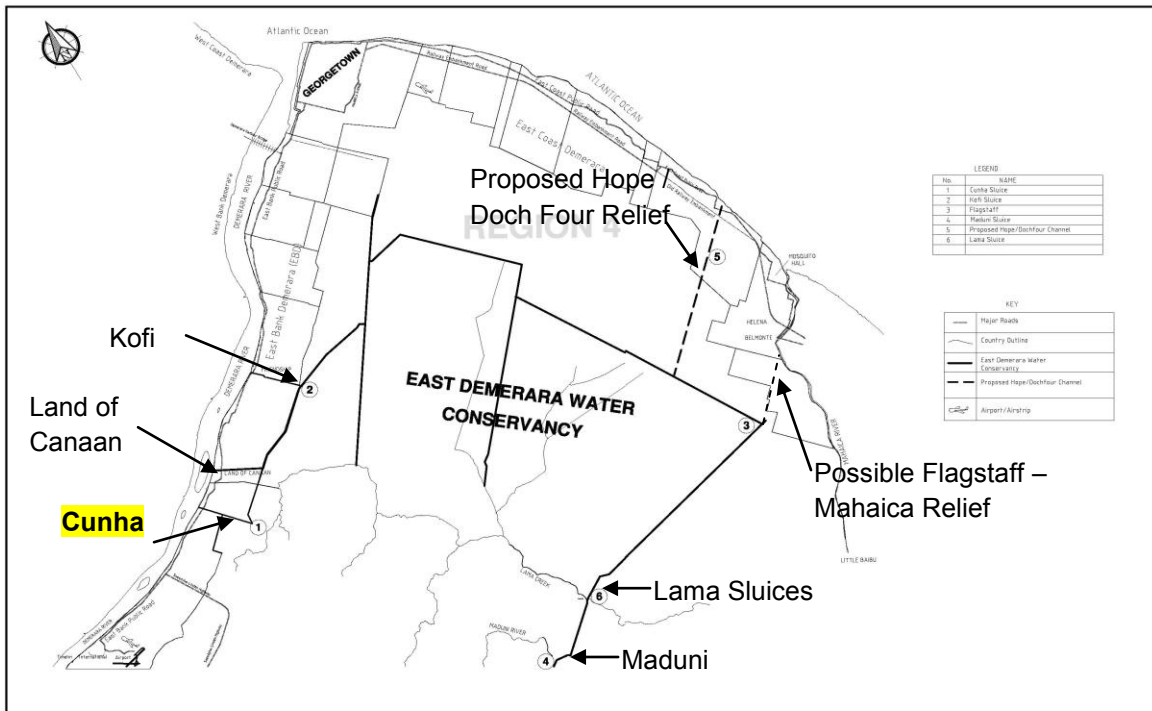
Figure 6: Map showing location of Cunha Canal

The Cunha Canal is located at Land of Canaan, EBD between the EDWC and the Demerara River. The Canal commences at the EDWC Western Dam and flows west for 2.8 km to the public road then turns south west towards the Sarah Johanna sluice. After passing through the sluice the Canal then flows through a culvert beneath the public road then west to the Demerara River.

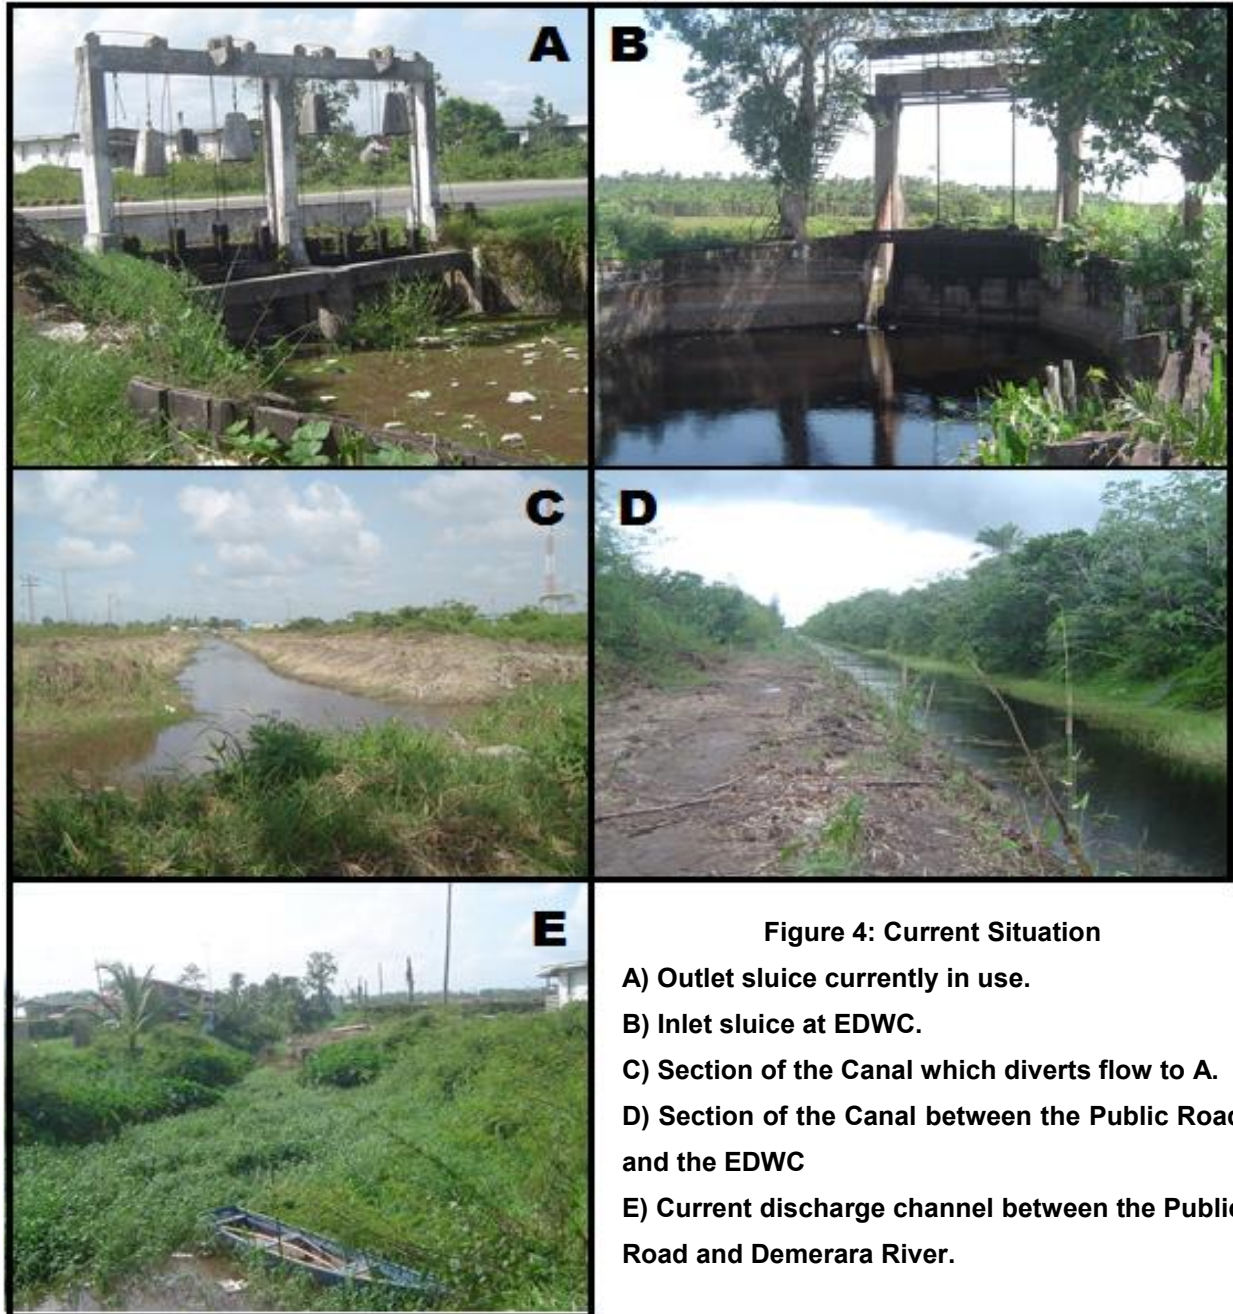
Figure 4: Current Situation

Land of Canaan (LOC). In addition, the discharge channel of the Canal in the vicinity of the Public Road was altered with the establishment of BCL Plywood and Sawmilling operations. Previously, the Canal flowed straight to the Demerara River through a sluice which was located along the Old Public Road. However, this area was sold to the Company around 1990 and the Canal was subsequently diverted south west along the new EBD Public Road and then through a sluice located between Land of Canaan and Sarah Johanna. The Canal was brought back into use following the 2005 floods when some rehabilitation works were done. The current situation is presented in Figure 4.

- A) Outlet sluice currently in use.**
- B) Inlet sluice at EDWC.**
- C) Section of the Canal which diverts flow to A.**
- D) Section of the Canal between the Public Road and the EDWC**
- E) Current discharge channel between the Public Road and Demerara River.**

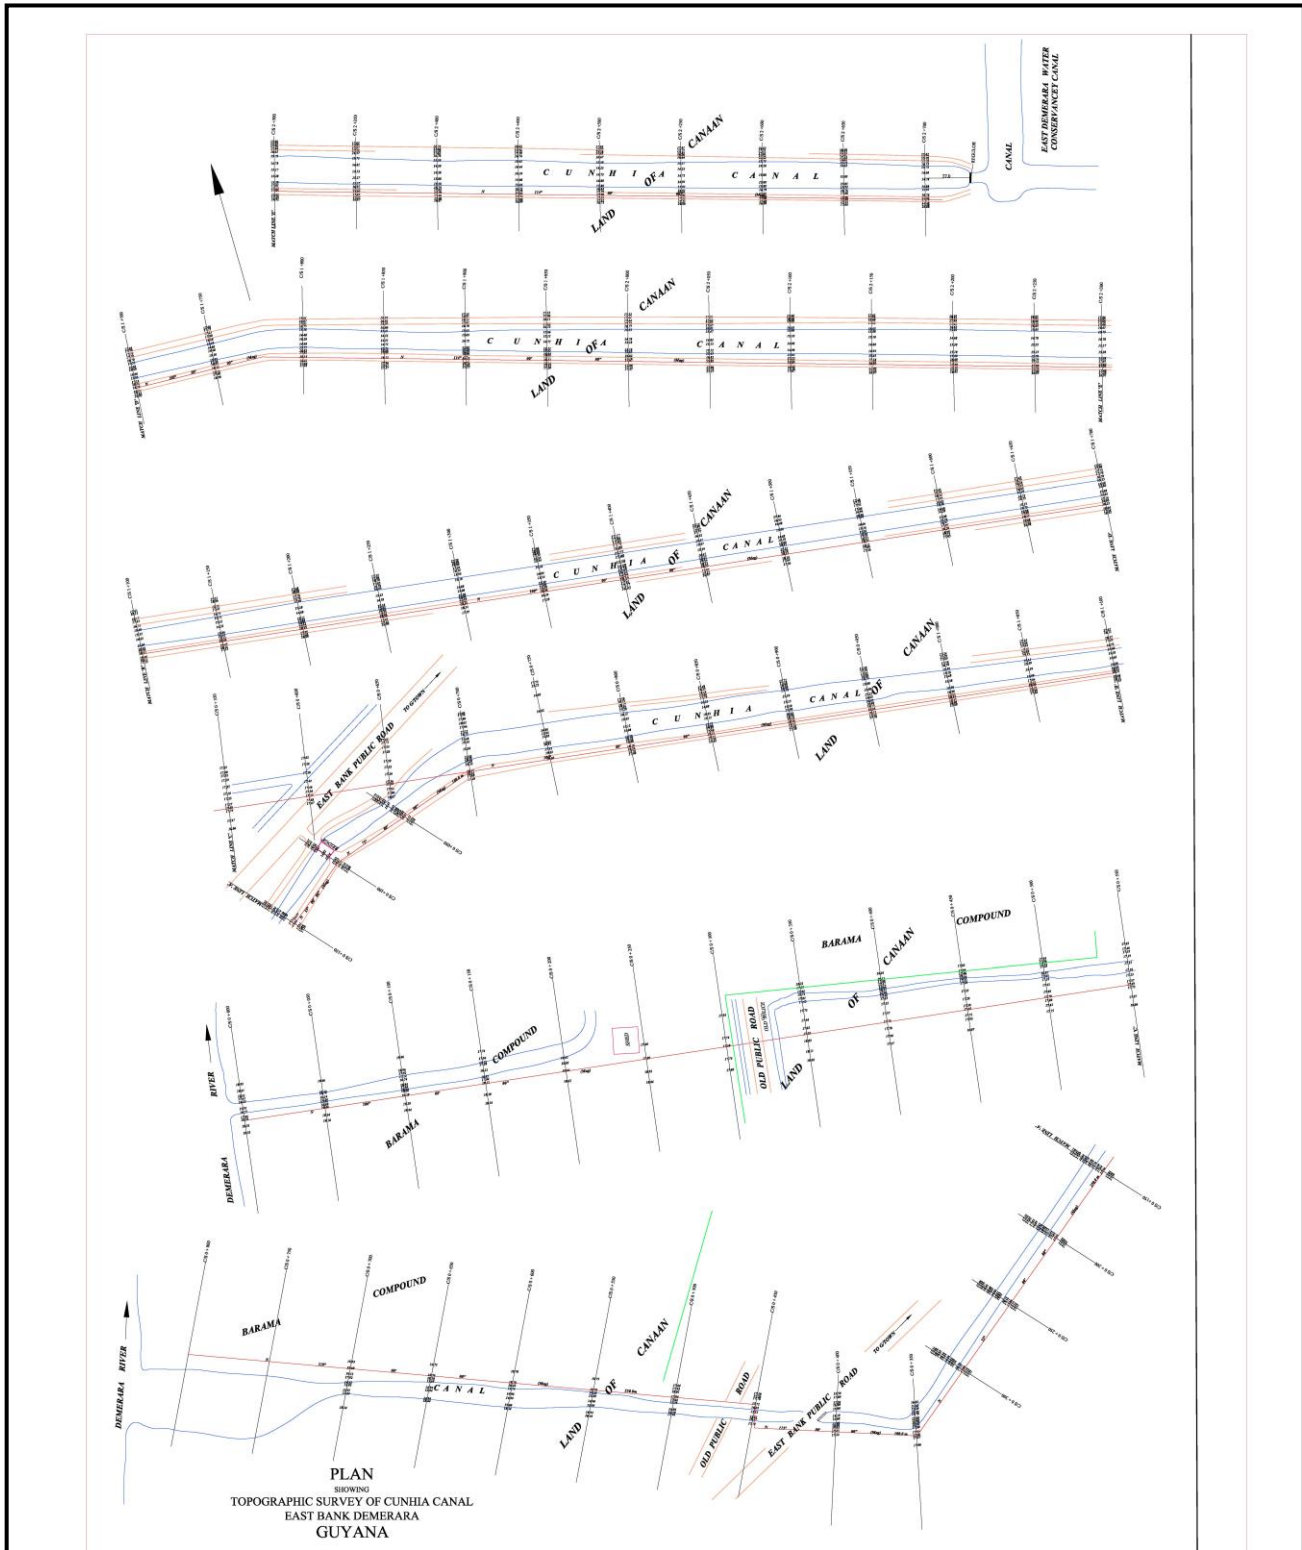
Figure 5: Map showing the current and proposed alignment of the Cunha Canal

The restoration of the defunct realignment of the channel to its original alignment will address these inefficiencies. A map of the existing and proposed alignment of the channel is shown in Figure 5.

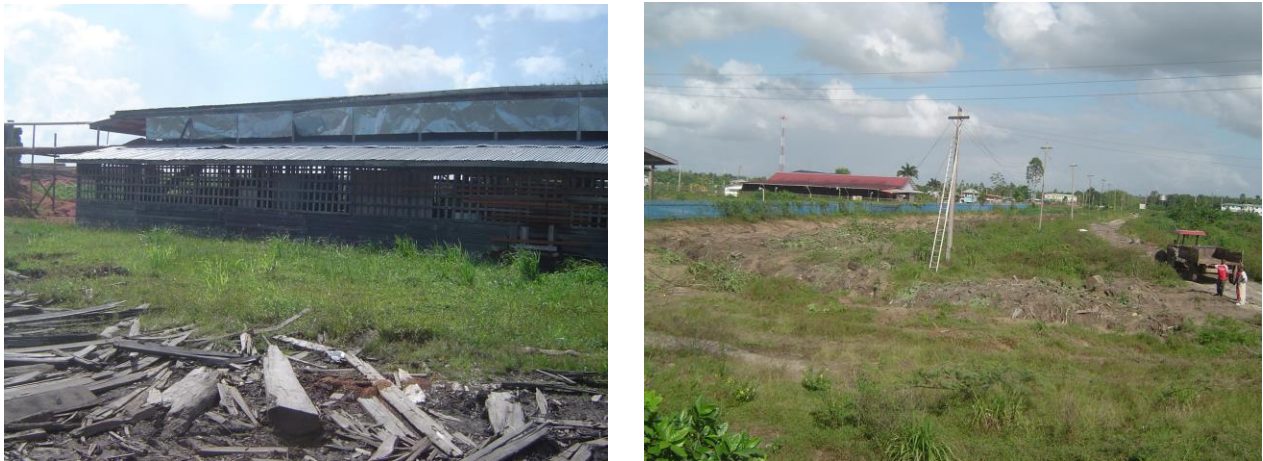
Figure 7: Secondary processing shed and the fence that would have to be relocated.

When the Canal was diverted to the current channel, BCL utilised the area along the old alignment between the sluice and the Demerara River for its operations. Some aspects of the operations are

currently located in close proximity to this alignment. These include a log pond, a secondary processing operation and a dust containment bin. The realignment of the canal to its original alignment will require some changes to the BCL operations. A survey was done to determine the buildings and other structures that would be affected. The result of this survey is outlined in Appendix F. The main building to be affected would be the Secondary Processing Shed. This is a large shed that house several pieces of equipment. Other areas to be affected include a fence on the southern boundary of the compound, a guard hut and a generator shed. Two (2) bridges that link the Company's log pond with the rest of the operation will also be affected.

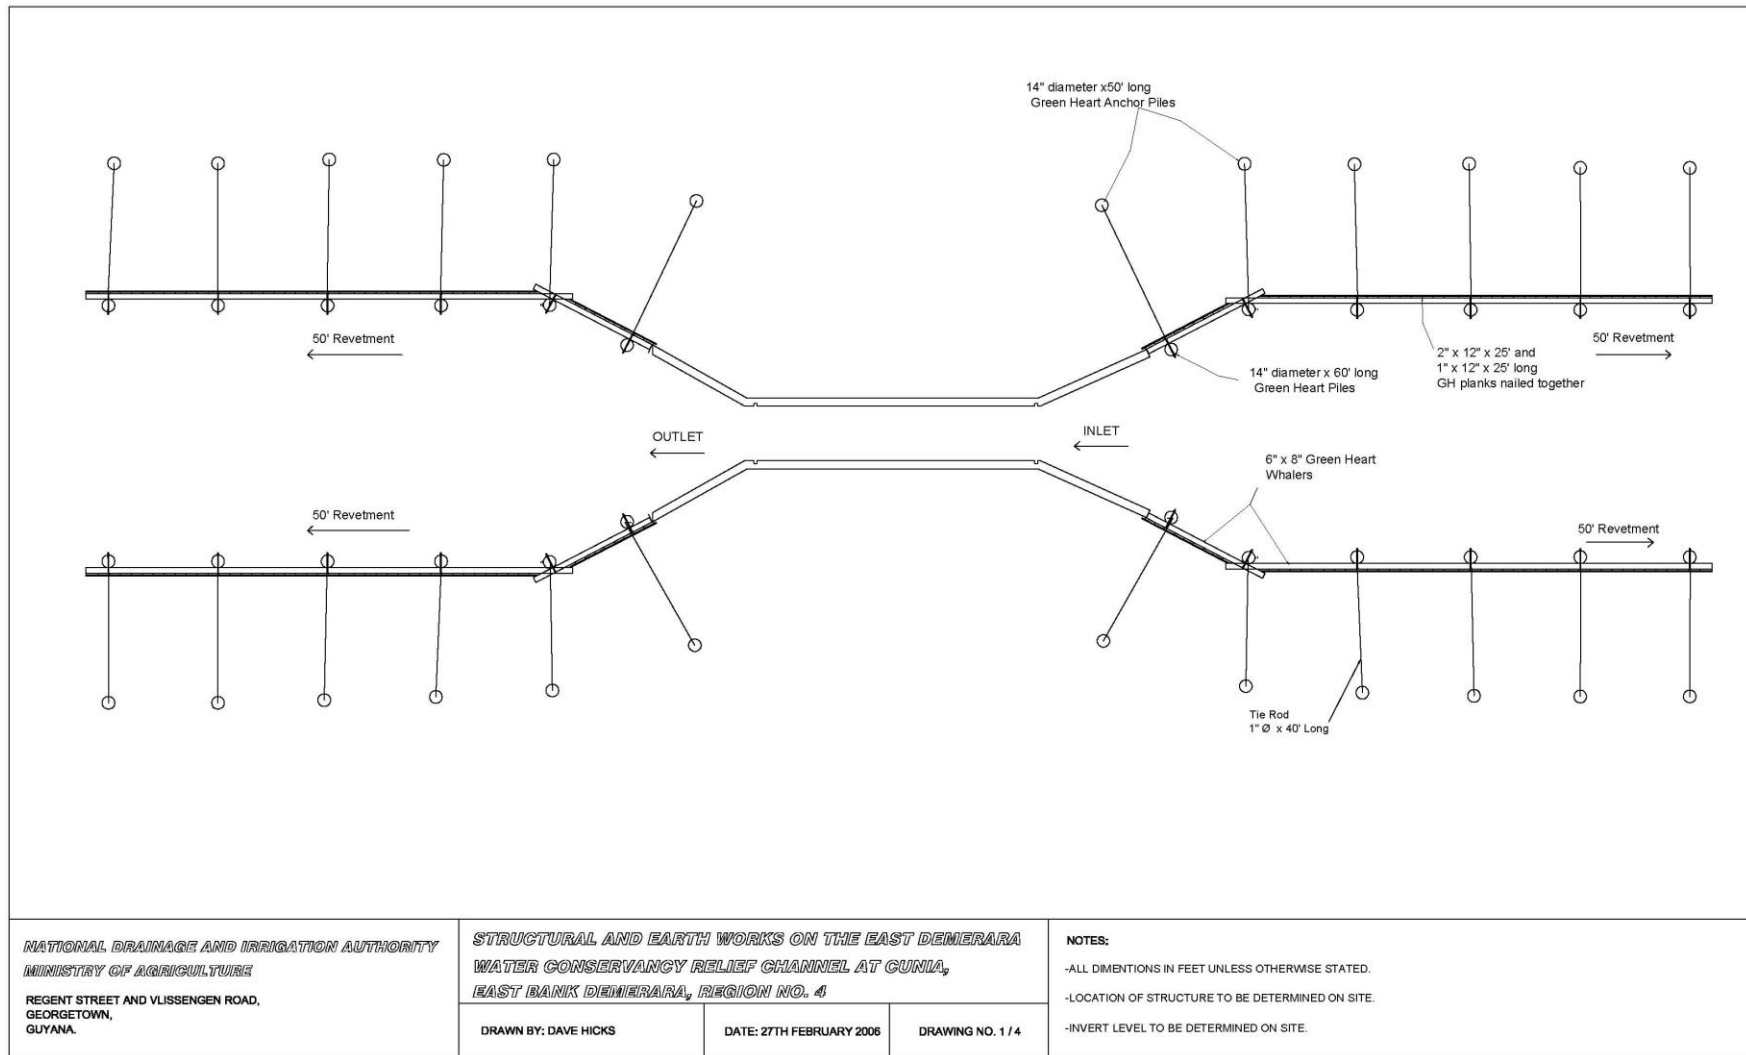
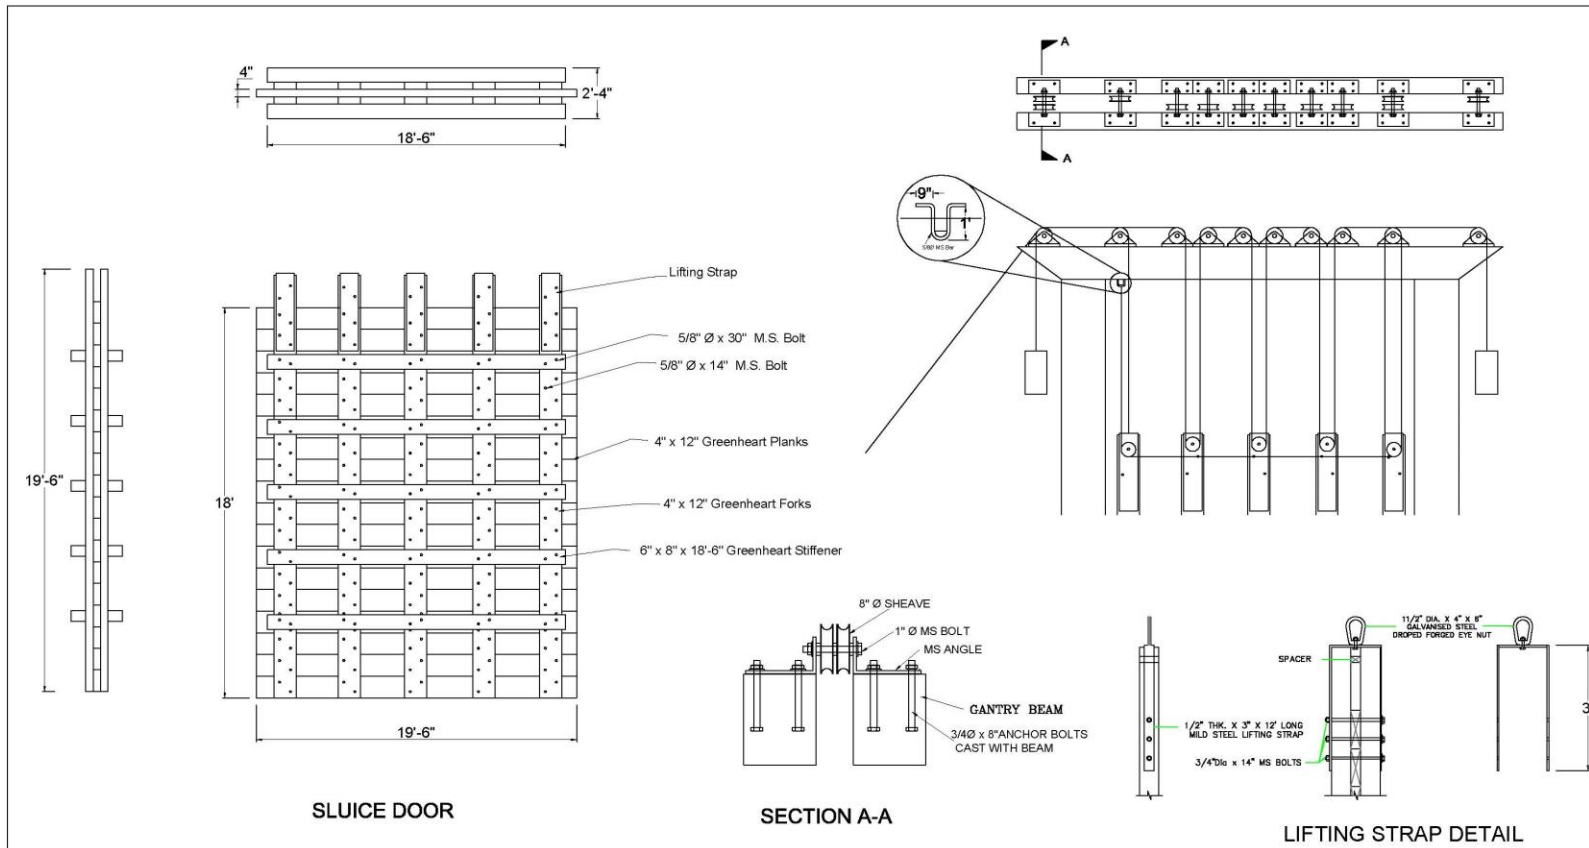
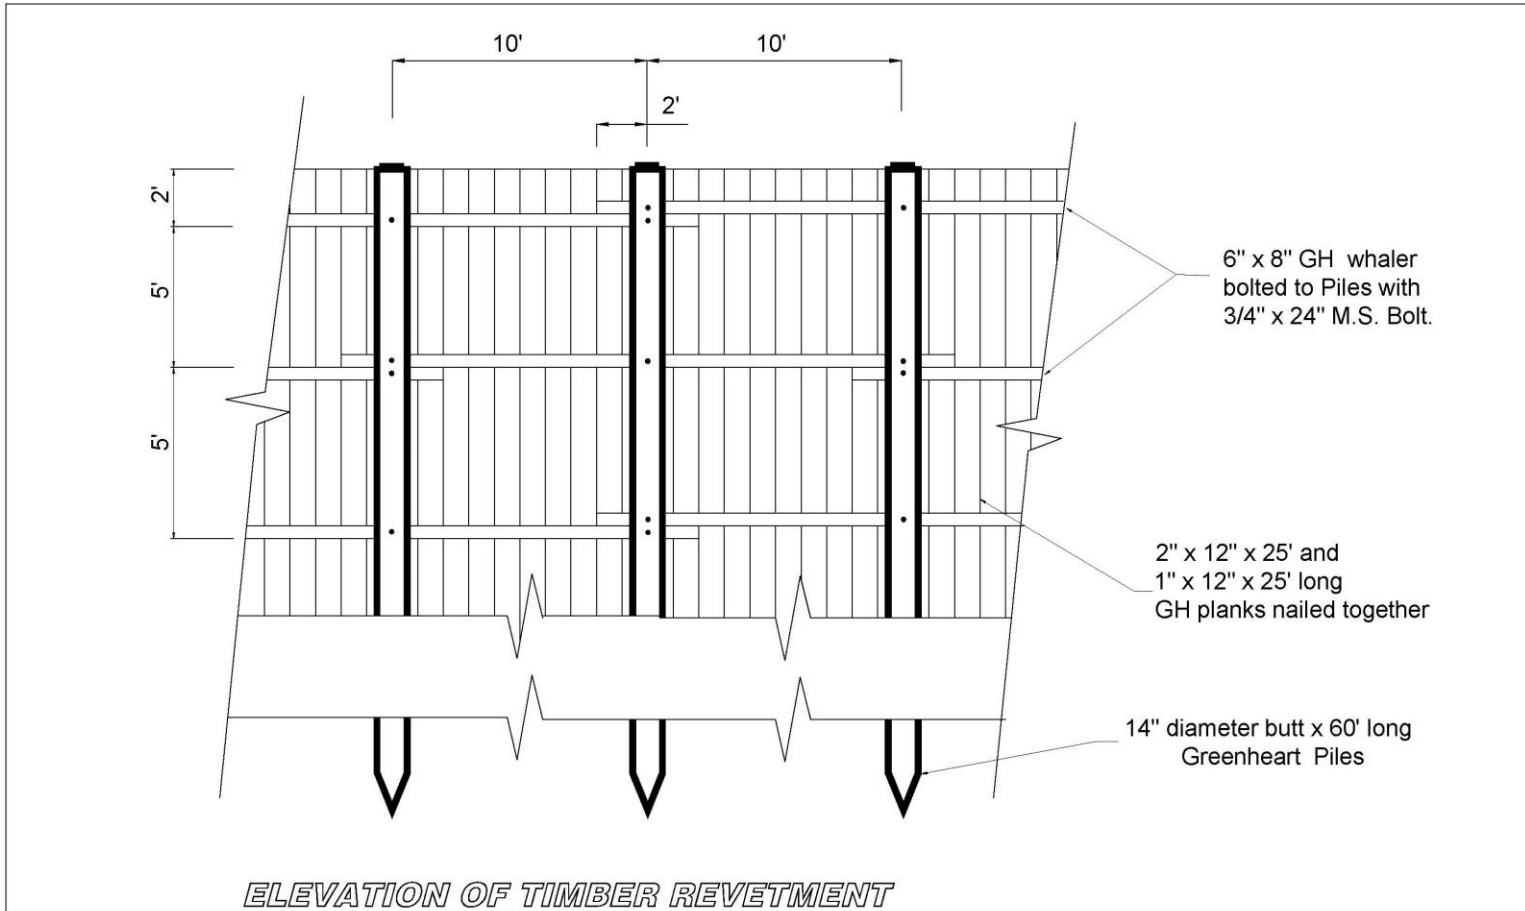
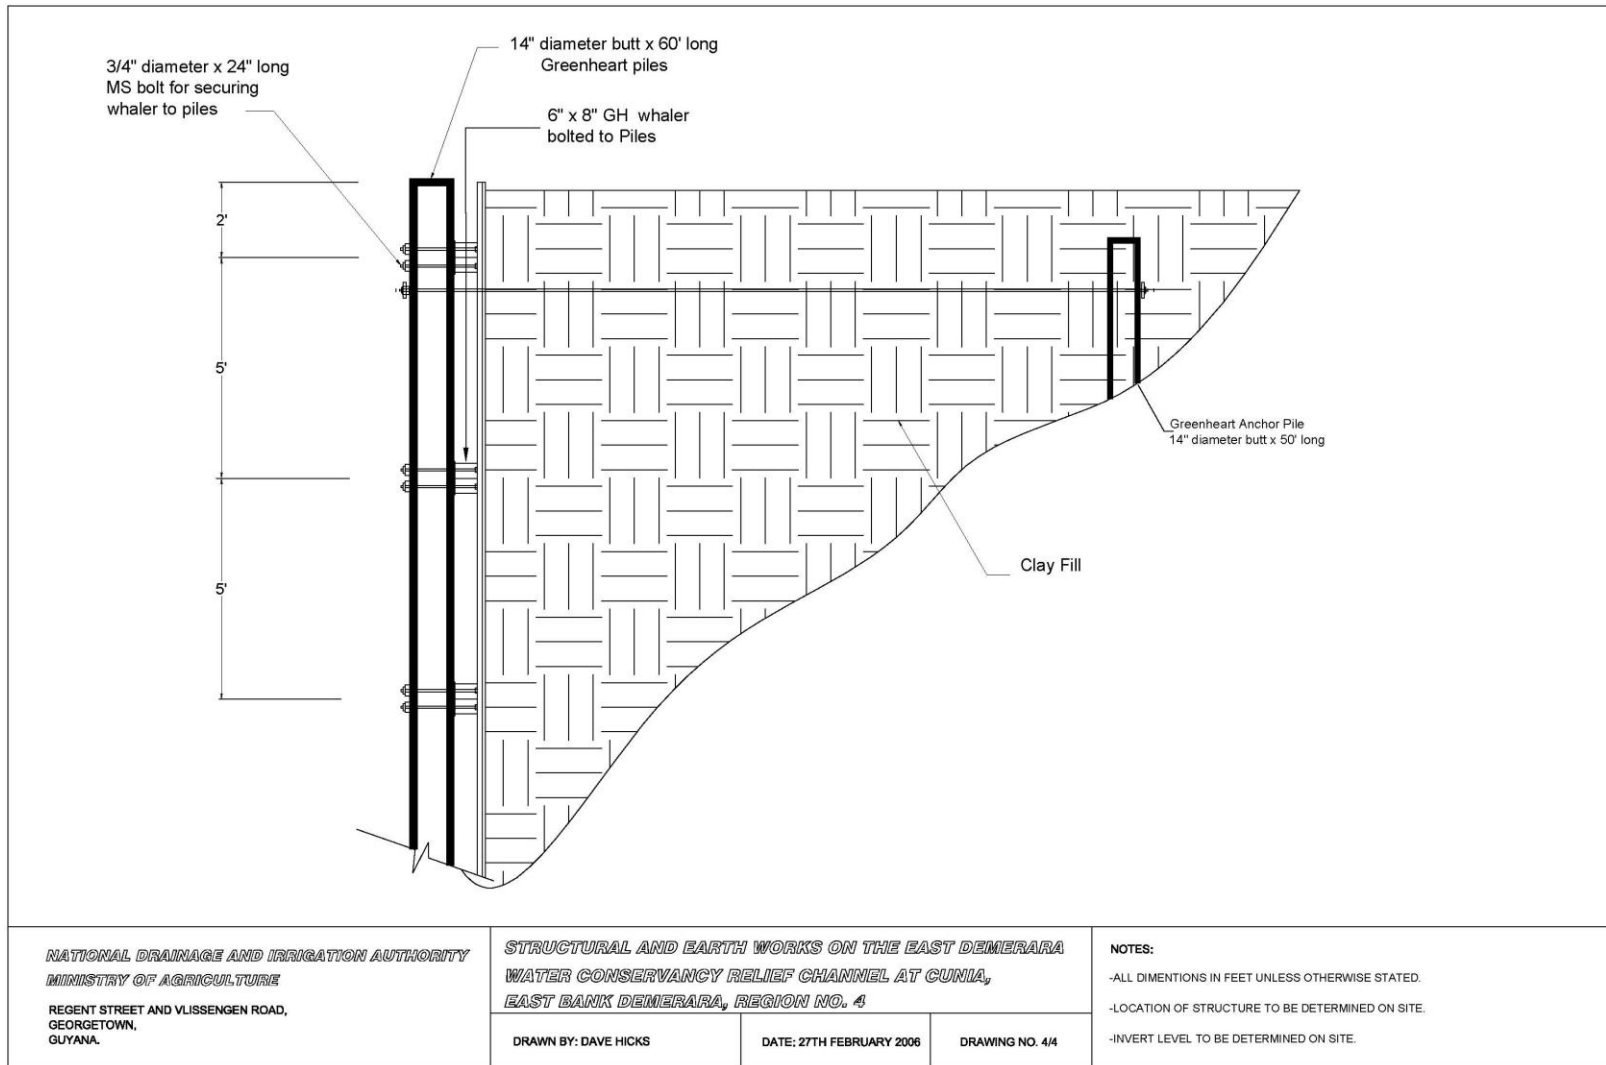
Appendix D – Drawings of the Sluice to be rehabilitated

STRUCTURAL AND EARTH WORKS ON THE EAST DEMERARA
 WATER CONSERVANCY RELIEF CHANNEL AT GUNIA,
 EAST BANK DEMERARA, REGION NO. 4

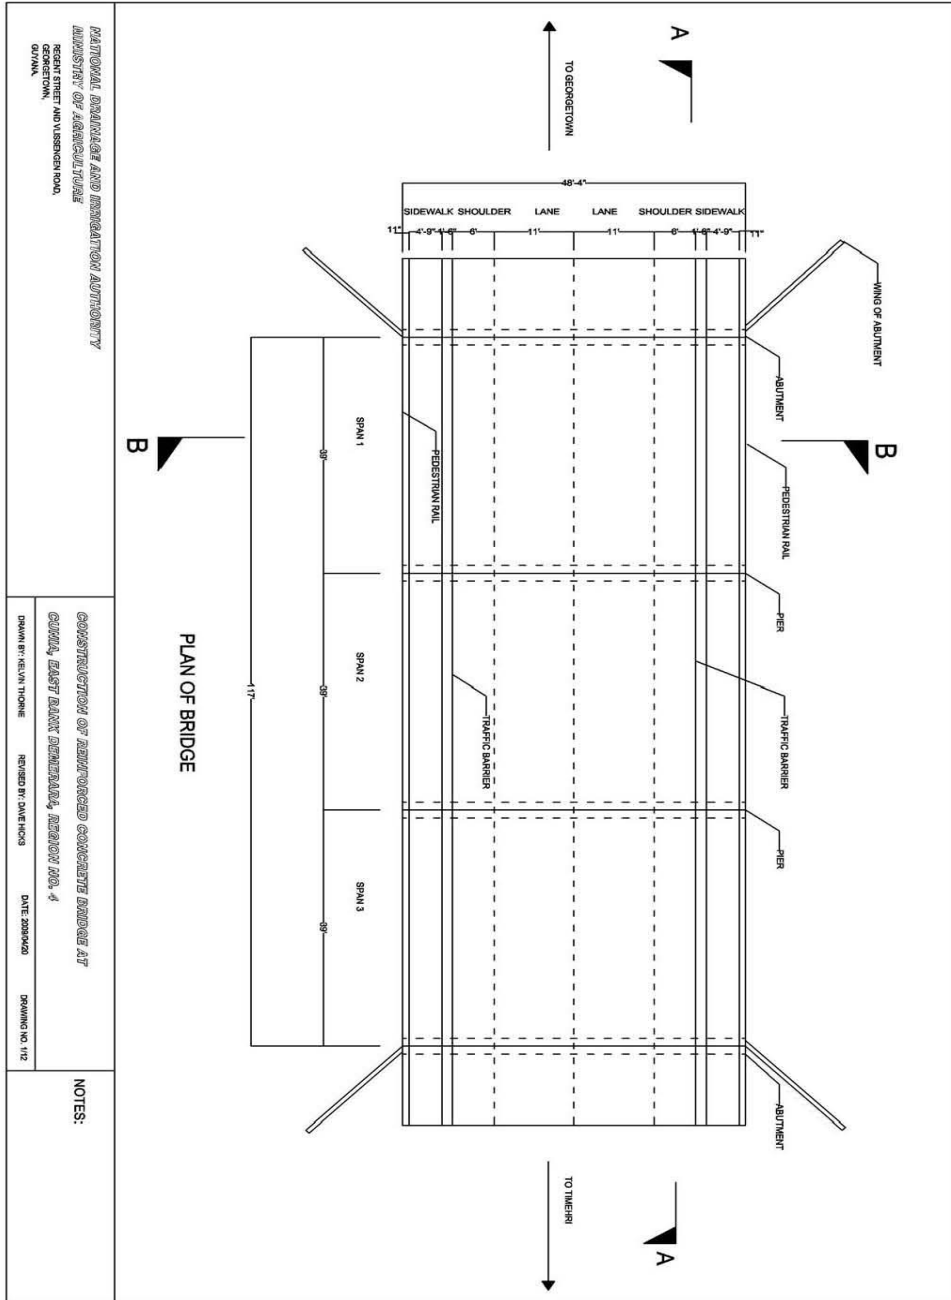
Plan of Bridge

- Construction of a bridge across the EBD Public Road.
A new bridge will be constructed at the point where the canal will intercept the EBD Public Road to allow vehicular traffic to traverse the area. Drawings of the bridge are attached as Appendix E.
